Danger tree breaks off, strikes faller

Purpose of this report

Number: 2005155980096

Core activity: Manual tree falling and bucking

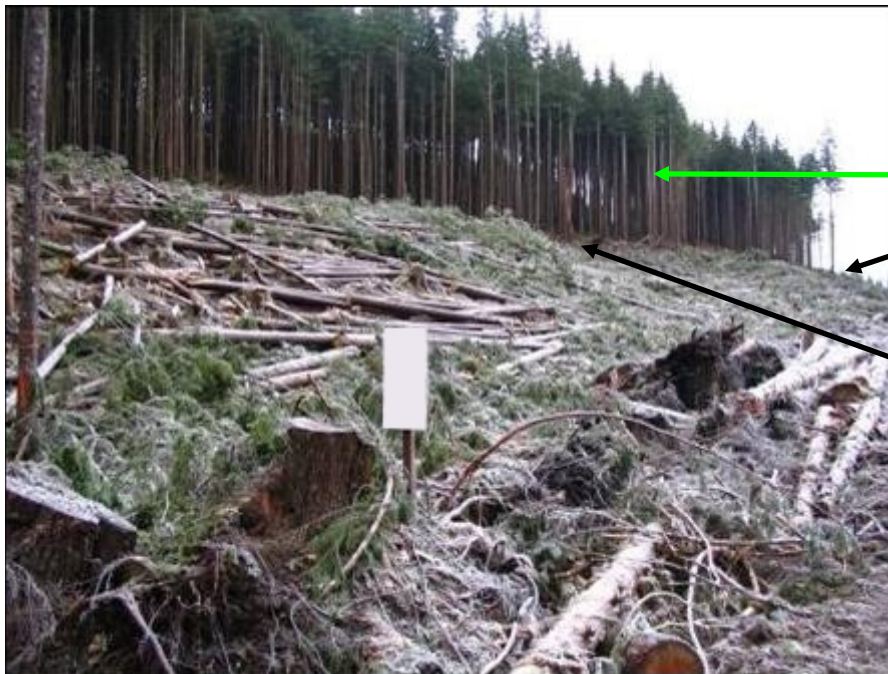
Photo 1: The cutblock as seen from the road.

The cutblock falling face

The partner's approximate work area

Incident scene and the faller's falling face

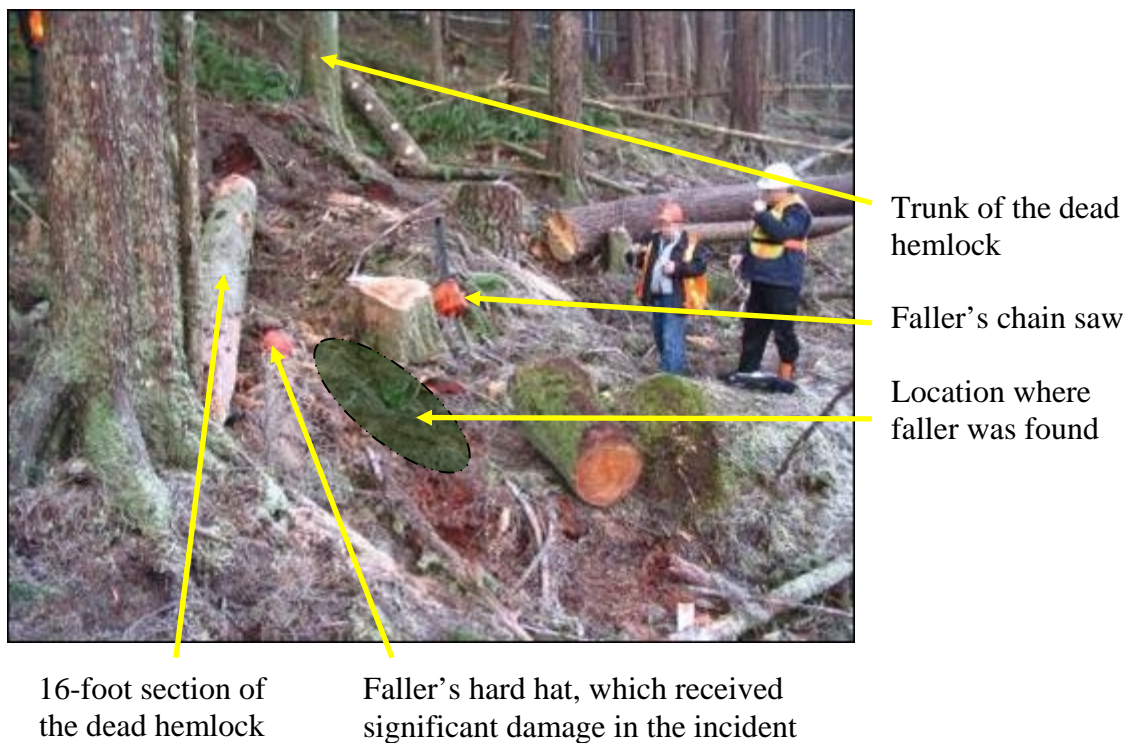
Photo 2: Incident scene.

Just before 1030 hours, the partner felled a dead cedar tree that ended up blocking a roadway. He went to get the faller's assistance to remove the fallen cedar. He found the faller lying on the ground adjacent to the falling face, unresponsive and with no pulse. The faller's saw, still running, was nearby. A 16-foot section of a fallen dead hemlock tree was near him (Photo 2). It was later determined that the faller was struck by the 16-foot section of tree.

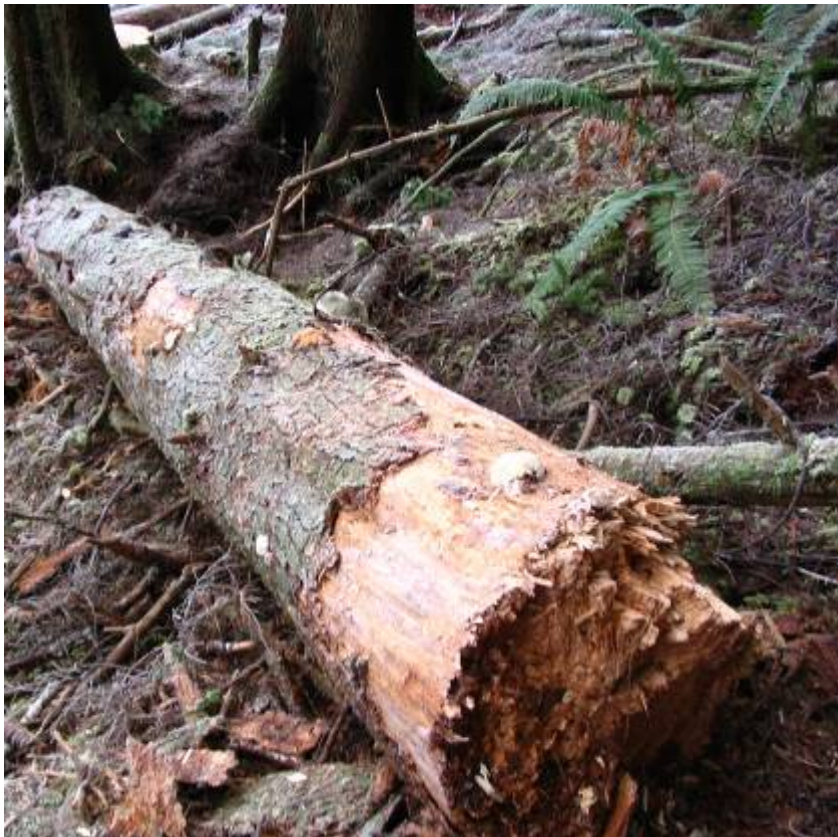
Photo 3: The 16-foot section of the danger hemlock tree that struck the faller.

After the incident, the hemlock danger tree was assessed by WorkSafeBC investigators and employer representatives. The tree was estimated to have been 65–70 feet tall and to have stood approximately 12 feet from the stump of the fir tree. It was approximately 22 inches in diameter at the location of the chain saw cuts. It was located just into the standing timber, uphill from the falling face, and likely had an uphill lean into the standing timber. The tree was limbless, was completely rotten above 10 feet, and had white fungus at various locations on the trunk (Photo 3).

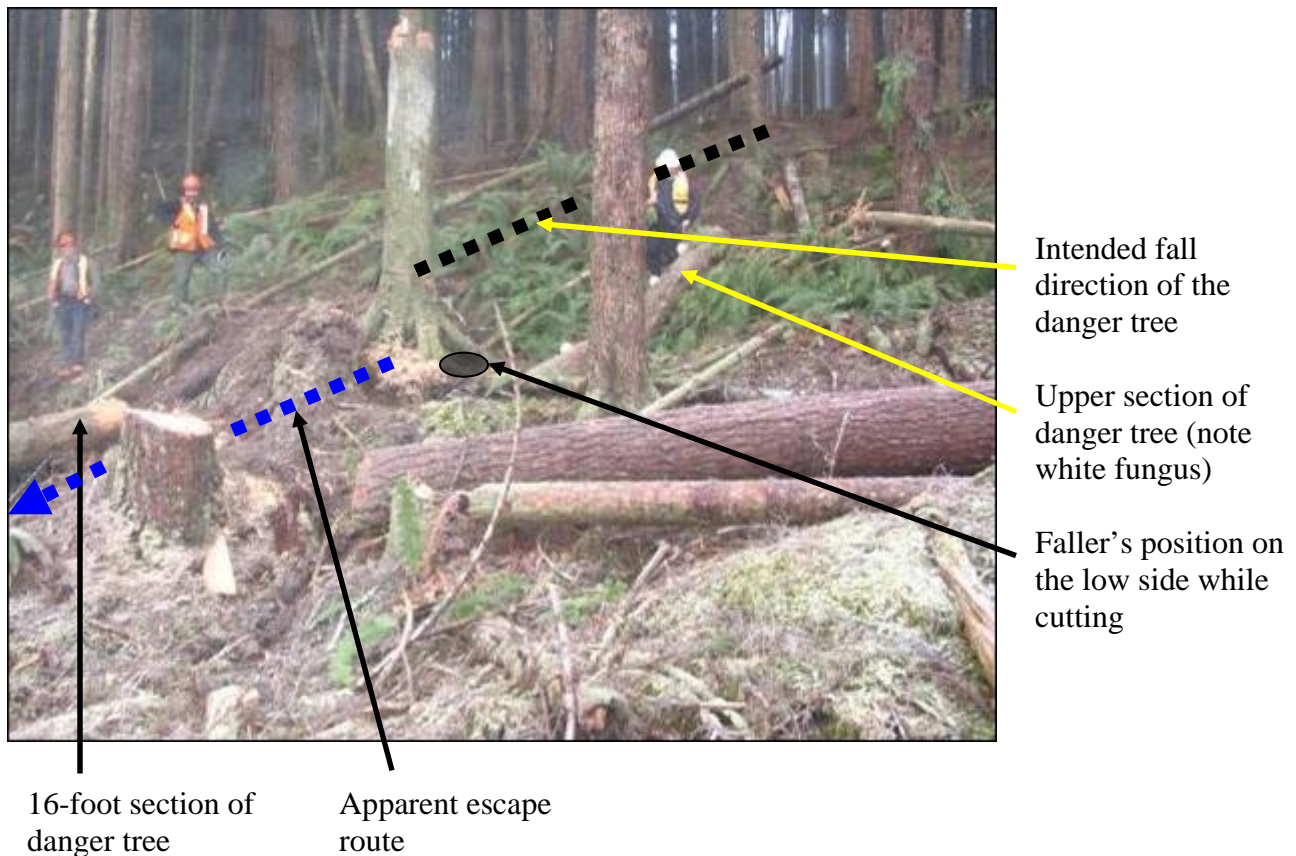
Photo 4: Faller's position while cutting the danger tree.

Based on the chain saw cuts, the faller intended the hemlock danger tree to fall uphill into standing timber. In order to accomplish this, the faller stood on the downslope (low) side of the hemlock danger tree (Photo 4). This created a high and somewhat awkward reach to make the saw cuts. In addition, the faller did not provide for a safe means of escape when the tree was committed to fall. The apparent escape route taken by the faller placed him in a potentially high-risk area in the event the hemlock danger tree broke apart (Photo 5).

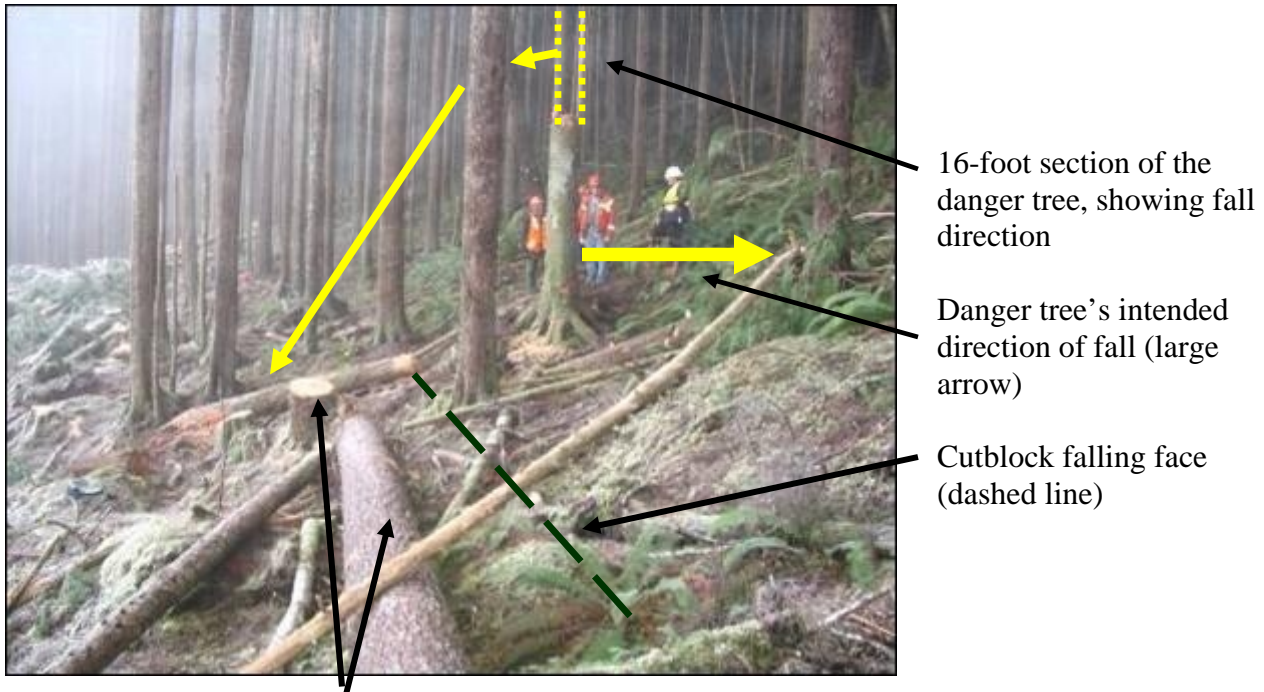
Photo 5: Hemlock danger tree.

The previously felled fir and stump

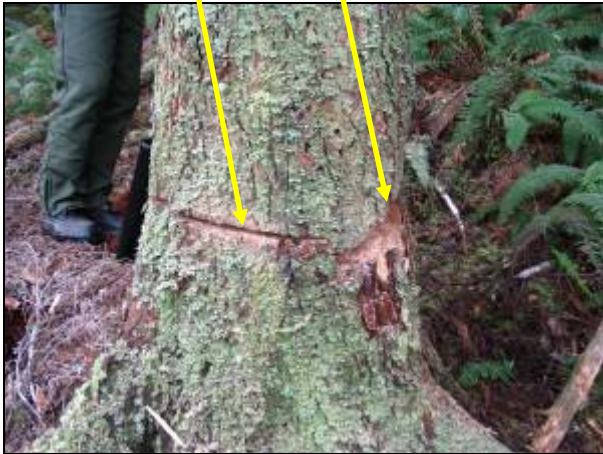
Photo 6: Low side of tree

In addition to the poor body position when making the saw cuts, the faller did not perform a proper undercut by leaving a 5-inch Dutchman on the high side of the cut (Photos 6 and 7). A Dutchman, created from insufficient removing of wood in the undercut, can significantly affect how a tree falls, including jarring the tree as it begins to fall. There was also a misalignment of the undercut and backcut (Photo 8).

Backcut Undercut

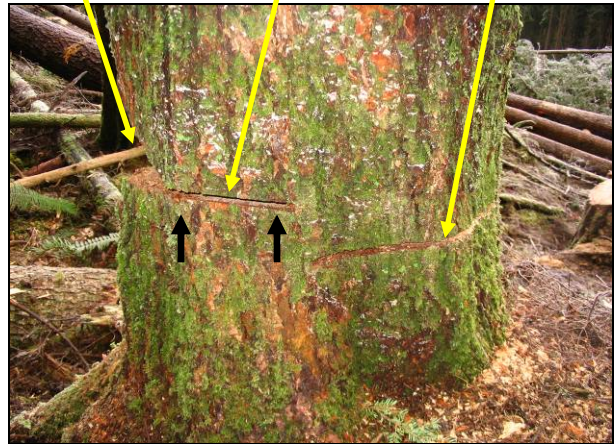
Photo 7: High side of tree, showing Dutchman

Undercut 5-inch Dutchman Backcut (black arrows)

Although the tree may have begun to break apart before the faller's cuts were completed, it is likely that the tree began to fall in the intended (uphill) direction as planned by the faller. The normally steady motion of the falling tree would have been almost immediately impeded by the 5-inch Dutchman. With a Dutchman, the unclean portion of the cut closes at the forward edge and the tree might hesitate or rock, thus generating a significant shock or jarring up the length of the tree and initiating the breakup of the tree. The top portion fell substantially uphill as planned, but the middle 16-foot section, supplied with a large amount of energy by the movement of the upper section, kicked back in the opposite direction, striking the faller. The bottom 9-foot section, which acquired very little energy or experienced very little movement in the process, simply sat back upright on the stump.

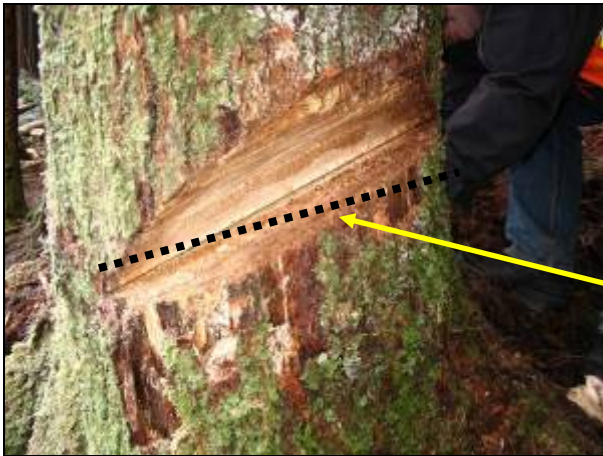
Photo 8: Undercut showing poor alignment

Undercut showing poor sighting relative to backcut (dotted line)
