## Worker struck by mobile equipment at plywood mill

At a plywood mill, a loader was carrying a load of peeled logs as it entered a large concrete tunnel called a vat. Peeled logs were being placed in the vat where the logs would be soaked with hot water for softening prior to being peeled into veneer for plywood. The load of logs struck a worker who was just inside the entrance to one of the vats. The worker received fatal crushing injuries.

Number: 2005130570147

Date: April 2005

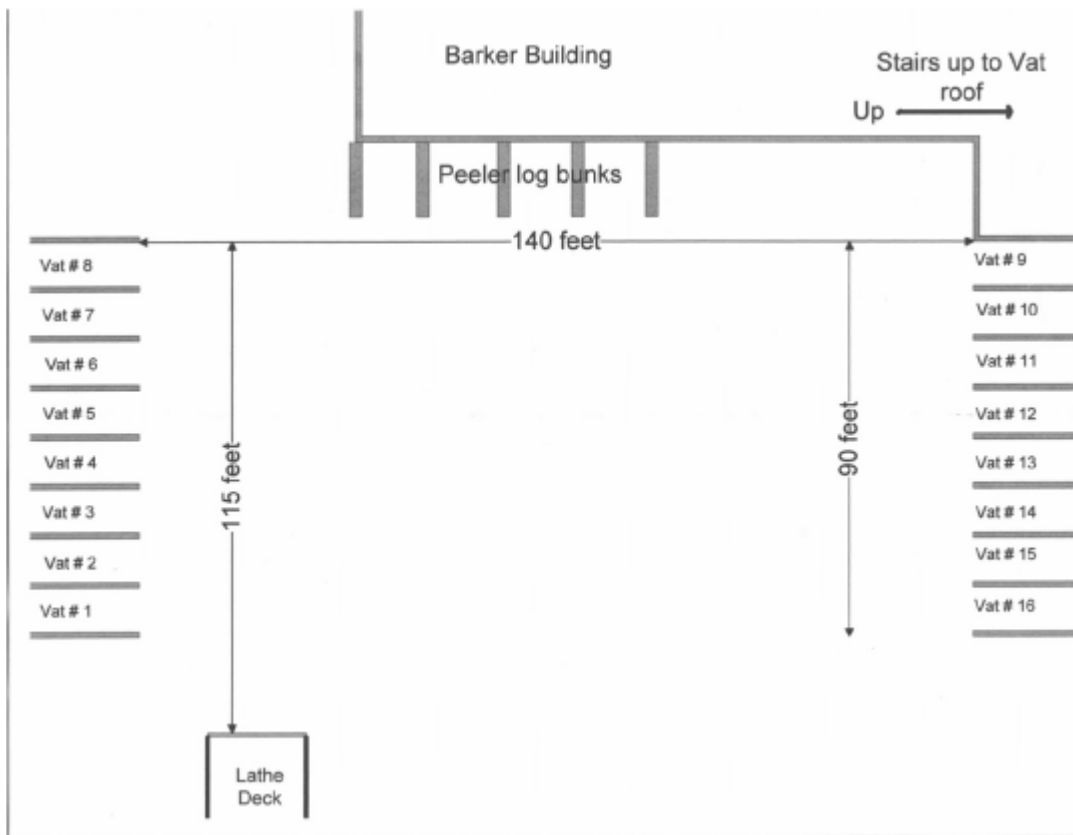
Figure 1: Layout of the vat pad at the plywood mill.

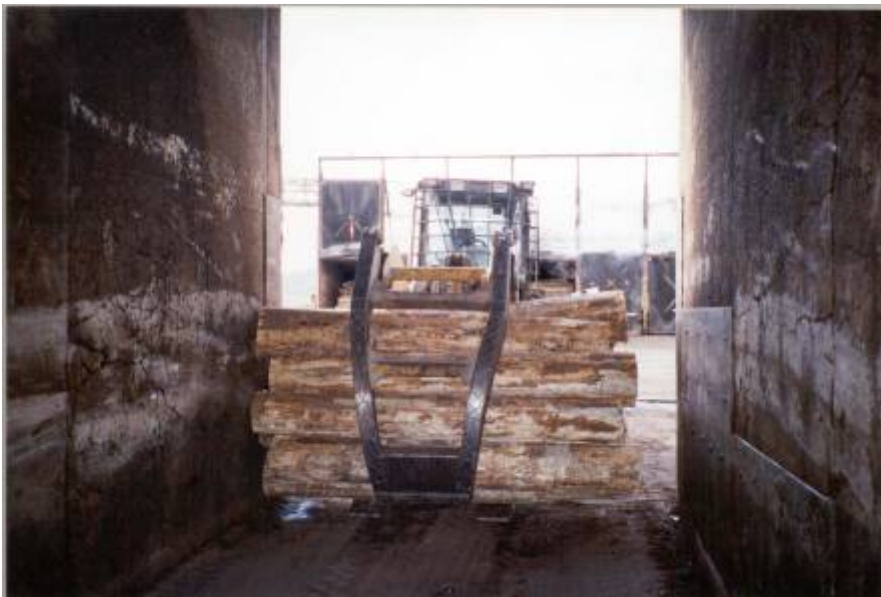
Figure 2: This photo demonstrates the typical clearance from the tunnel walls when a log loader places peeler logs in a vat.

The machines are large and moving at a high rate of speed in a relatively small working area. A loader can take a load from the peeler bunks to a vat or from a vat to the lathe deck in about 2 minutes, a cycle that goes on for 2 or 3 hours while the machine loads or unloads a vat. Two loaders may be working at the same time; one loader could be loading a vat while the other is unloading a vat. They may both be working the same side of the vat pad or one on each side. This requires the operators to be well aware of the location of the other loader and any pedestrians on the vat pad.

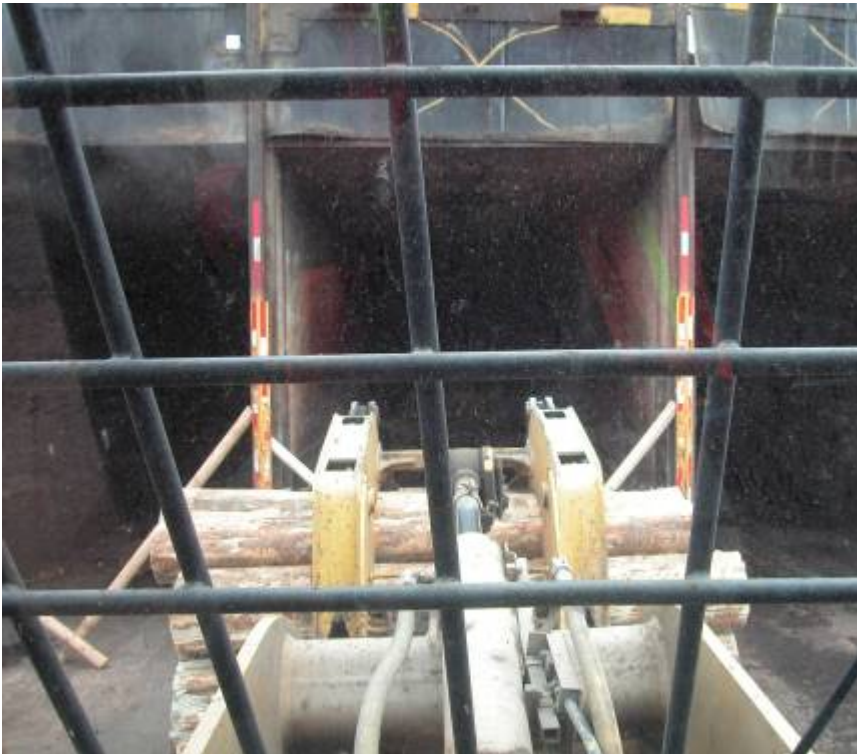
The loader operator's front visibility is somewhat restricted due to the cab screening and the load being carried in front (see Figure 3). The operator's rear visibility is also limited due to the cab height and the engine compartment behind the cab. Because of the visibility restrictions, persons who walk on the vat pad during the operation of the loaders are exposed to an increased risk of being struck by a loader. Communication with the loader operators by radio or visual contact is crucial to the safety of any pedestrian traffic on the pad.

Figure 3: The photo demonstrates the typical view from the cab as a loader approaches a vat. It is not intended to show exactly what the loader operator saw at the time of the incident.

The evidence indicates that at the time of the incident there was no communication either visual or via radio between the vat man and the loader operator involved in the incident. This breakdown in communication along with the limited visibility from the loader cab increased the risk of an incident occurring.

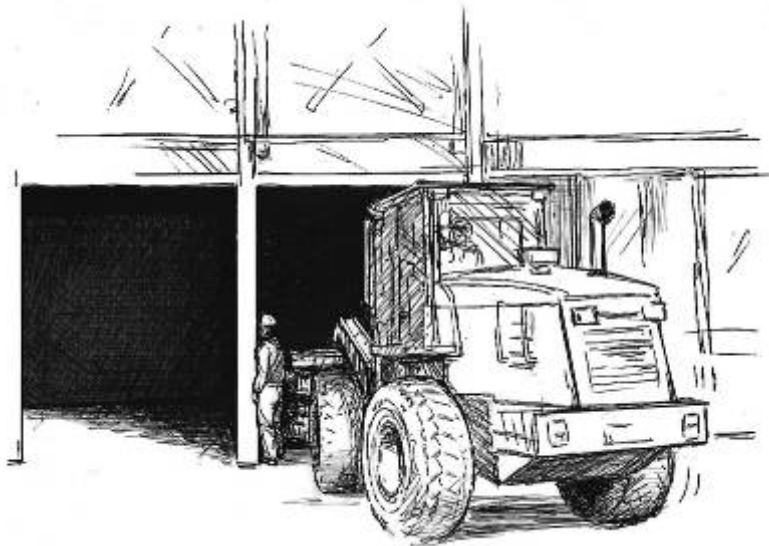
As Loader Operator 1 entered vat 12, he spotted the vat man coming out of the vat entrance between the tunnel wall and the peelers carried by the loader (see Figure 4). Loader Operator 1 realized the load of logs on the loader had struck the vat man. Loader Operator 1 stopped his loader, attended briefly to the injured vat man, and then ran to get first aid assistance. The vat man died in hospital from his injuries.

Figure 4: The drawing shows the position of the vat man when the loader operator saw him after he had been struck by the load of peeler logs.

A loader entering a vat tunnel with a load of peeler logs without the loader operator's knowledge that the vat man was located inside the vat. The vat man was struck by the load of peeled logs.

- The vat man was not visible to the loader operator. The loader operator's visibility was limited, and the vat entrance was dark.
- The loader operator was unaware that the vat man had accessed the vat pad area.
- The access to the vat pad area lacked clearly defined and enforced protocols. The employer had not identified who could access the vat pad or how and when the vat pad area could be accessed.
- A proper risk assessment had not been conducted for the vat man's required duties.
- The written job procedures for the vat man did not clearly identify and emphasize the hazards, particularly the degree of risk associated with fast-moving loaders and pedestrian traffic.
- Previous near misses of equipment and pedestrians on the vat pad had not been properly investigated and no corrective actions had been taken to prevent future incidents.

- Develop a proper written job procedure for the vat man position that clearly defines when it is necessary for the vat man to enter this area and the steps required before entry. The procedure should include, but not be limited to, proper communication with mobile equipment operators, when vat tunnels can be accessed, and the steps to be taken to ensure equipment cannot enter the tunnel when workers are in the tunnel.
- Ensure that only workers required to enter the vat pad area are permitted in this area and that they are provided with all necessary instructions and communication protocols.
- Develop processes to report and investigate all serious near misses for prevention purposes.

Immediately after the incident, the employer initiated a change in the vat man's written job procedure and stopped all access to the vat pad when the loaders are operating. The vats and pad area have now been officially designated as a restricted area and the following protocol has been implemented: Prior to any person entering the vat pad or the vats, operators must be contacted by radio. The operators will then stop their loaders and lower the loader log grapples and confirm by radio that their machines are stopped and grapples lowered. The loaders will not be allowed to move until the person or persons confirm by radio contact that they have left the now-restricted area.
