Danger tree breaks off, strikes faller

Purpose of this report

Number: 2005155980096

Core activity: Manual tree falling and bucking

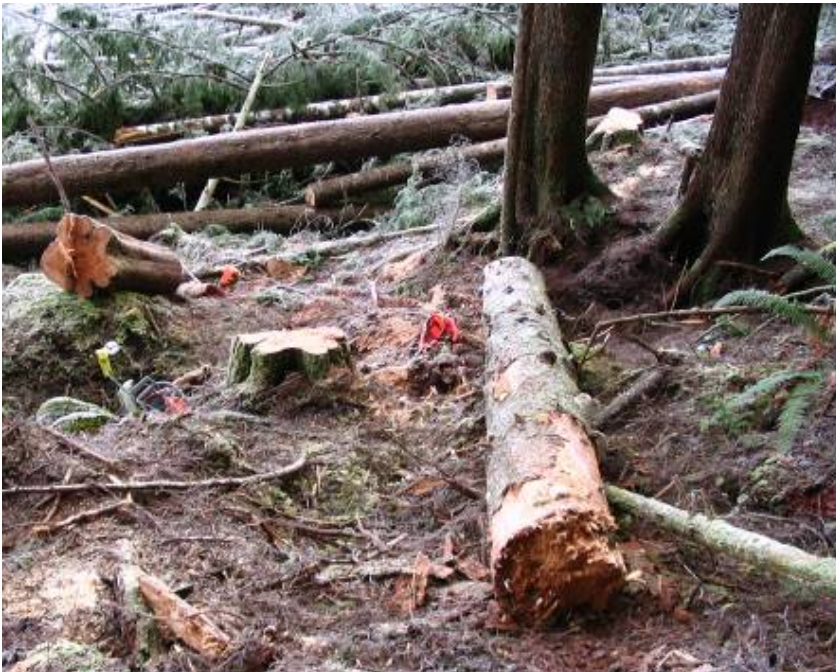
A manual faller was working in a cutblock. He made the cuts to fall a dead hemlock tree (a snag, or danger tree). The undercut left a 5-inch Dutchman, and when the tree started to fall, a 16-foot section broke off. It fell in the direction opposite to that of the intended fall of the tree and struck the faller, causing fatal injuries.

The top approximately 45 feet of the hemlock danger tree landed more or less in the intended location. Due to its rotten condition, it broke apart into a number of pieces of various sizes. As the tree was falling into standing timber, it knocked down a few smaller trees. Approximately 9 feet of the tree directly above the saw cuts remained vertical on the stump. A 16-foot section immediately above the bottom 9-foot section was pushed backward downslope.

The faller's injuries were consistent with being struck on the head by the 16-foot section of the hemlock danger tree as he moved downhill on his escape route. Some of the damage to the hard hat may have resulted from crushing by the section of the hemlock danger tree once the hat had fallen to the ground. It appeared the faller was heading toward a grove of trees, approximately 10 feet further downhill. The location and position of the faller's chain saw indicated he probably dropped it at the same time as or just before being struck by the tree.
